Re: Ilegal Discharge of sewage into coastal waters in Aguadilla, Puerto Rico

PHOTOGRAPHIC RECORD

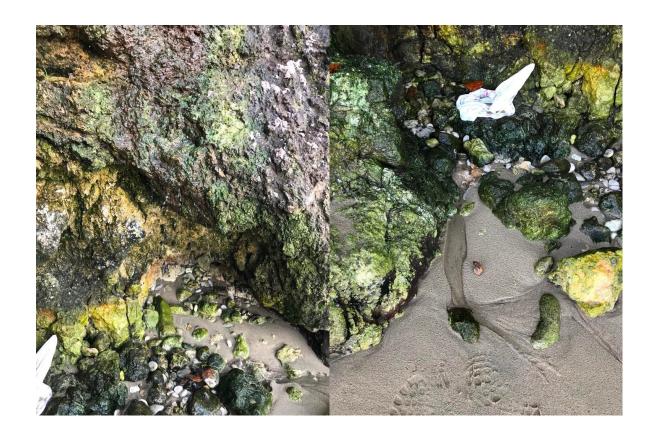
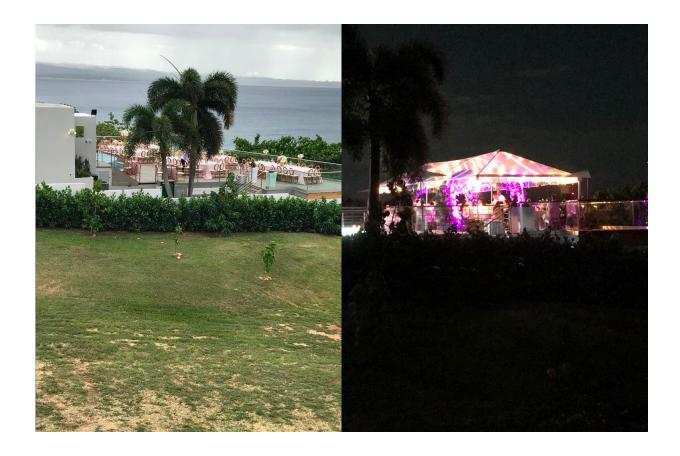
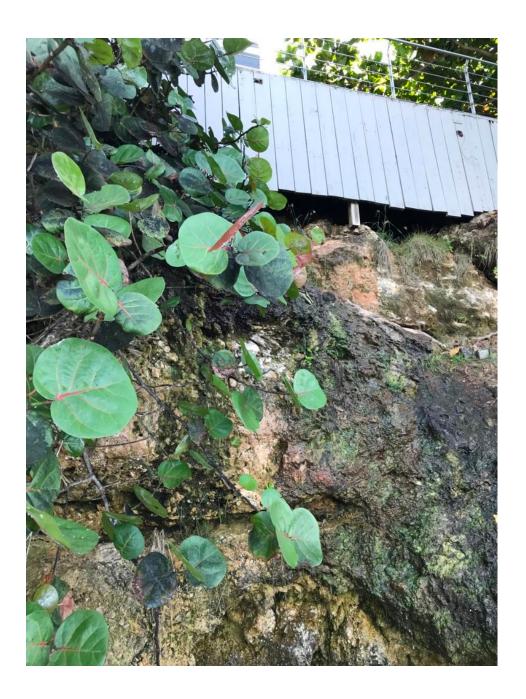
On April 25, 2022, we inspected an illegal discharge of sewage coming from a residence located at Solar #4 Calle Ibiza Carr. 107 KM 2.7 INT Bo. Borinquen, sector Playuela Aguadilla, PR 00603. The property owners are Anaudi Hernández Pérez and Verónica N. Ponce Peña with cadastre number: 023-004-331-53-000. The house is currently being used as an events venue that attracts large numbers of guests and as a temporary/vacation rental property (commonly known as a short-term rental), and not as its intended original purpose when built as a single-family residence.

Our firm was retained by Mr. James Connor, owner of a property located to the north of the above-referenced property, to conduct an initial assessment of the existing conditions in the area. We noted the continuous flow of a discharge with solids and a very unpleasant smell in the nearby coastal waters during the inspection. Blue-green algae (cyanobacteria) is visible on the walls and sedimentary rocks where the release runs. The flow comes directly from an opening in a concrete structure similar to an above-ground storage tank. The tank or concrete structure is part of the house. We noticed that the entire parcel is being occupied by construction with no area available for a septic or sewage treatment structure from the initial observations. The property's location does not have sanitary sewer lines operated by the Puerto Rico Sewer and Aqueducts Authority, forcing all property owners to depend on septic systems to treat their wastewaters.

The house's area is formed by clay deposits mixed with limestone and sedimentary rocks. Areas where clay deposits and limestone are common present percolation problems due to the nature of the soils and rock formations. It is common to observe overflows and discharges from failing septic systems. This problem is aggravated by the intense use of the property during significant events held on weekends when dozens of people stay on the premises exceeding the septic system capacity causing the discharge to run into the coastal waters.

We respectfully request immediate assistance from your agency to inspect to stop this unlawful discharge of pollutants into an essential natural resource enjoyed. Below we have included a series of images describing the existing conditions in the area. We are available to support any investigation or provide additional information to help address this vital issue.
